**Fiat Punto**  
Emotion 90HP

## Car Details

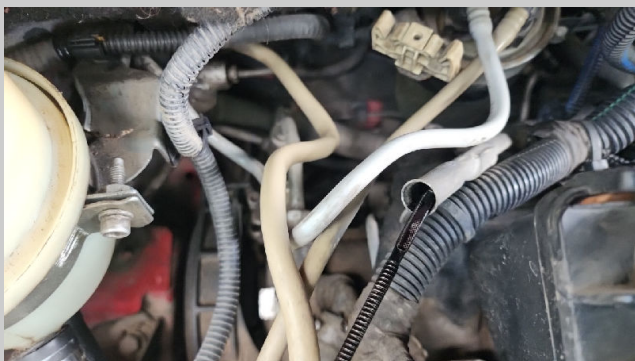
| Part | Status | Reason | Comment |
|---|---|---|---|
| Engine Oil & level | Not Ok | Black color | |

Black color

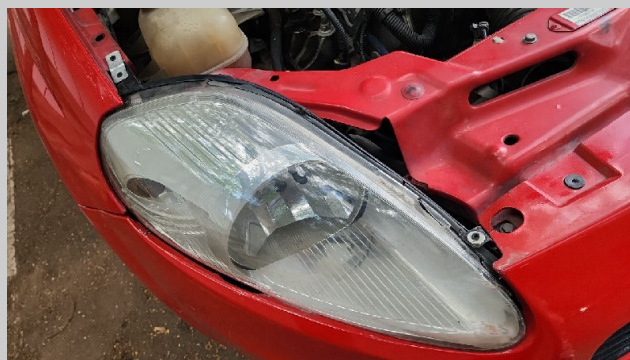
| Part | Status | Reason | Comment |
|---|---|---|---|
| LH: Head Lights | Not ok | Broken clamps,Feaded | |

Broken clamps,Feaded

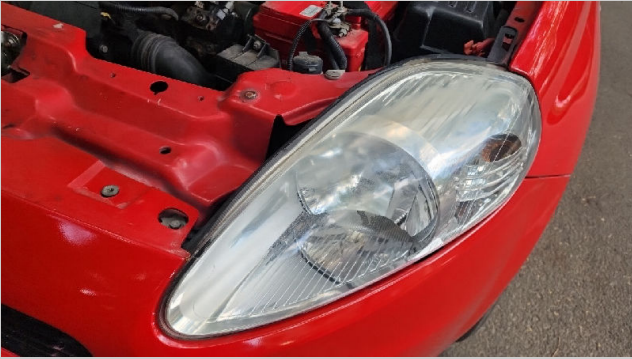
**RH: Head Lights**

| Part | Status | Reason | Comment |
|---|---|---|---|
| RH: Head Lights | Not ok | Feaded | |

Feaded

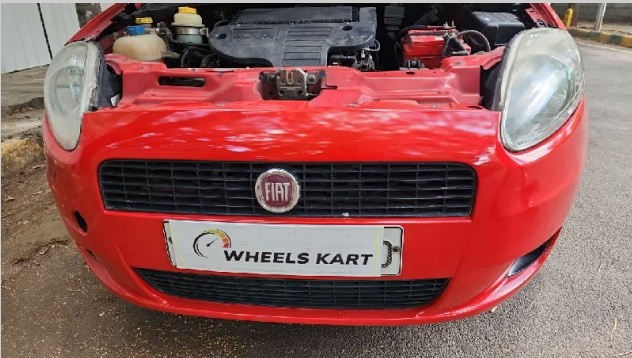
**Front bumper**

| Part | Status | Reason | Comment |
|---|---|---|---|
| Front bumper | Not ok | Part Repaired,Repainted good quality | |

Part Repaired,Repainted good quality

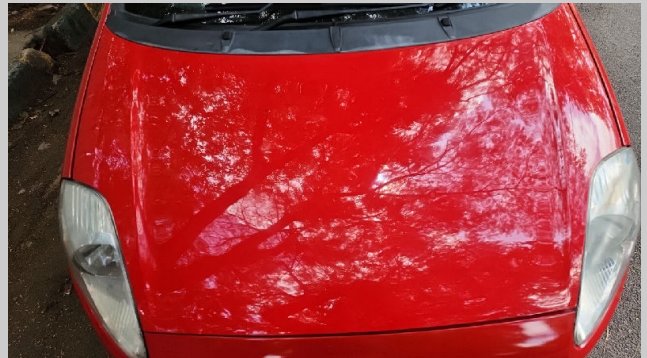
**Bonnet Hood**

| Part | Status | Reason | Comment |
|---|---|---|---|
| Bonnet Hood | Not ok | Repainted good quality,Major or Multiple Dents,multipe minor scratches | |

Repainted good quality,Major or Multiple Dents,multiple minor scratches

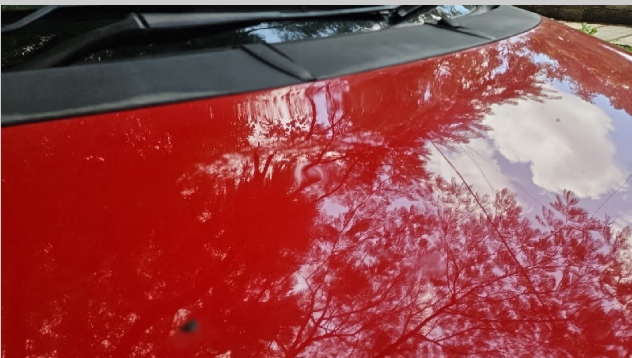
**Bonnet Hood**

Repainted good quality,Major or Multiple Dents,multiple minor scratches

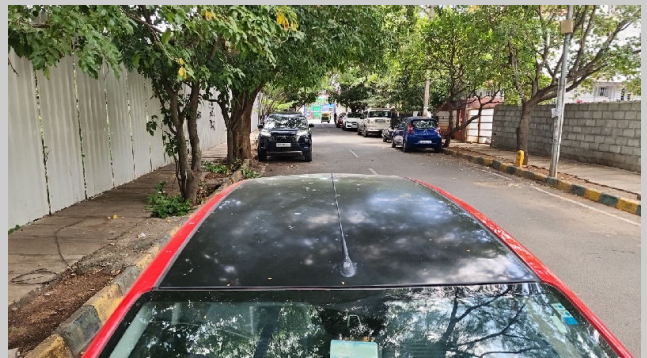
**Roof**

| Part | Status | Reason | Comment |
|---|---|---|---|
| Roof | Not ok | Repainted good quality,Major or Multiple Dents,multipe minor scratches | |

Repainted good quality,Major or Multiple Dents,multiple minor scratches

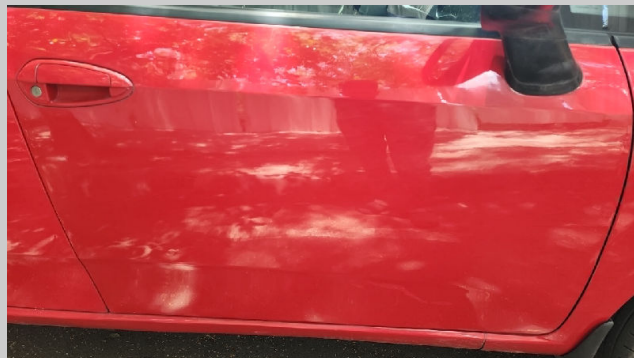
**RH Front Door**

| Part | Status | Reason | Comment |
|---|---|---|---|
| RH Front Door | Not ok | Repainted good quality,Minor scratches | |

Repainted good quality, Minor scratches

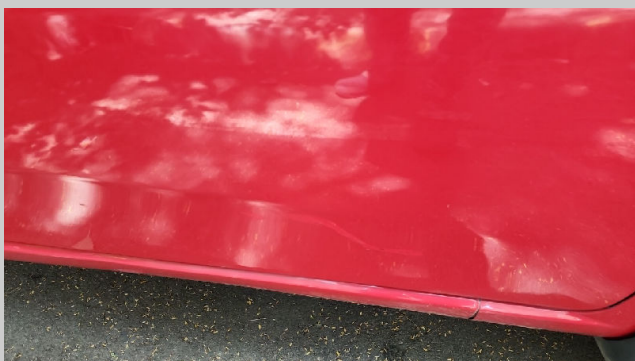
**RH Front Door**

Repainted good quality, Minor scratches

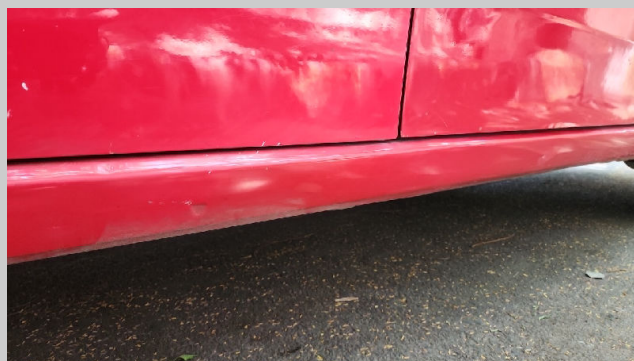
**RH Running Board**

| Part | Status | Reason | Comment |
|---|---|---|---|
| RH Running Board | Not ok | Part Repaired,Repainted good quality | |

Part Repaired, Repainted good quality

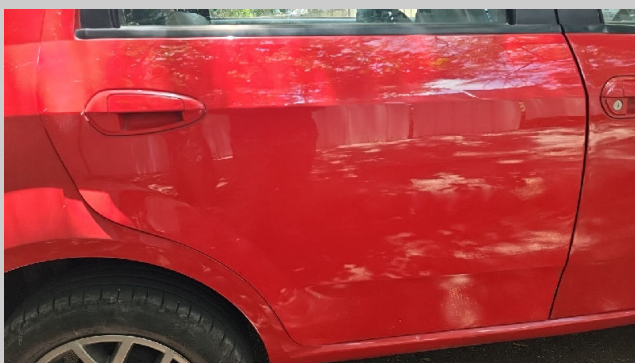
**RH Rear Door**

| Part | Status | Reason | Comment |
|---|---|---|---|
| RH Rear Door | Not ok | Repainted good quality | |

Repainted good quality

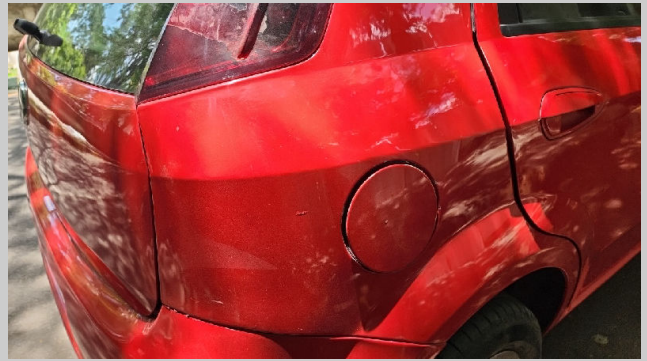
**RH Quarter Panel**

| Part | Status | Reason | Comment |
|---|---|---|---|
| RH Quarter Panel | Not ok | Part Repaired,Major or Multiple Scratches,Minor scratches | |

Part Repaired, Major or Multiple Scratches, Minor scratches

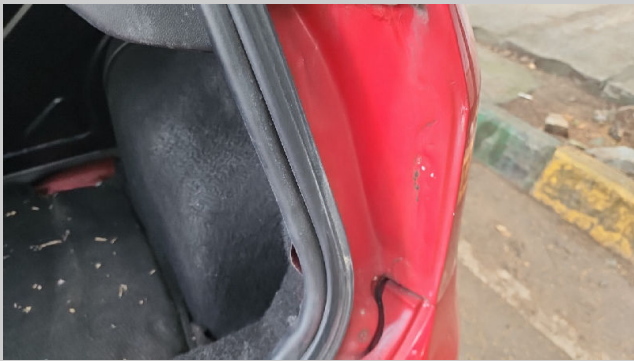
**RH Quarter Panel**

Part Repaired, Major or Multiple Scratches, Minor scratches

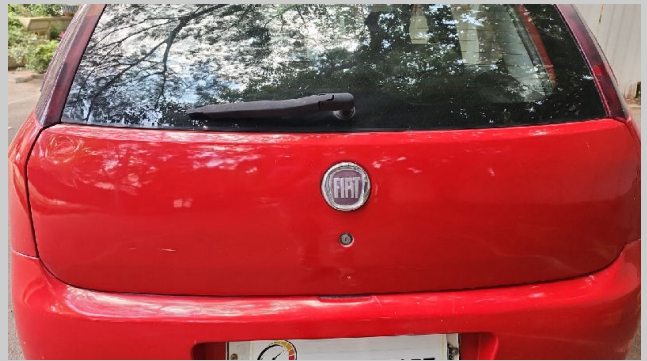
**Trunk Tail Gate**

| Part | Status | Reason | Comment |
|---|---|---|---|
| Trunk Tail Gate | Not ok | Part Repaired,Repainted good quality,Major or Multiple Dents | Dicky lifter needs replacement |

Part Repaired, Repainted good quality, Major or Multiple Dents

Dicky lifter needs replacement

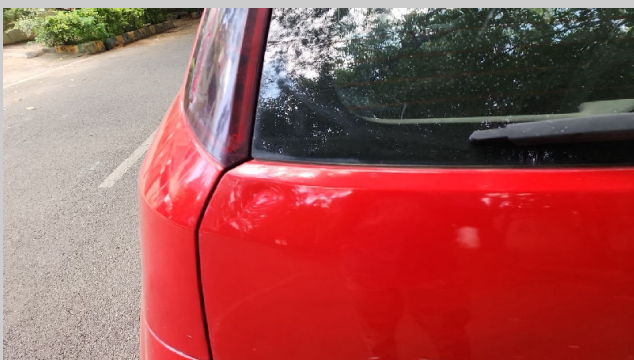
**Trunk Tail Gate**

Part Repaired, Repainted good quality, Major or Multiple Dents

Dicky lifter needs replacement

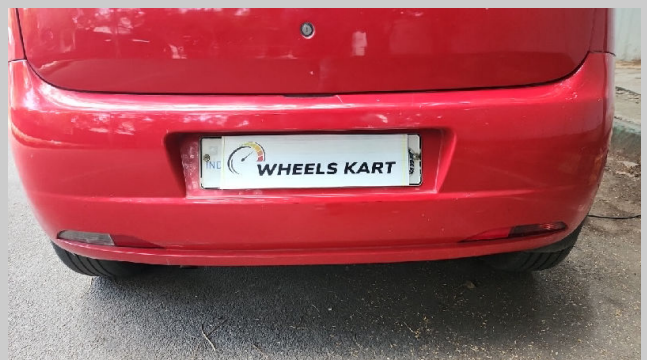
**Rear bumper**

| Part | Status | Reason | Comment |
|---|---|---|---|
| Rear bumper | Not ok | Part Repaired,Repainted good quality,Minor scratches | |

Part Repaired, Repainted good quality, Minor scratches

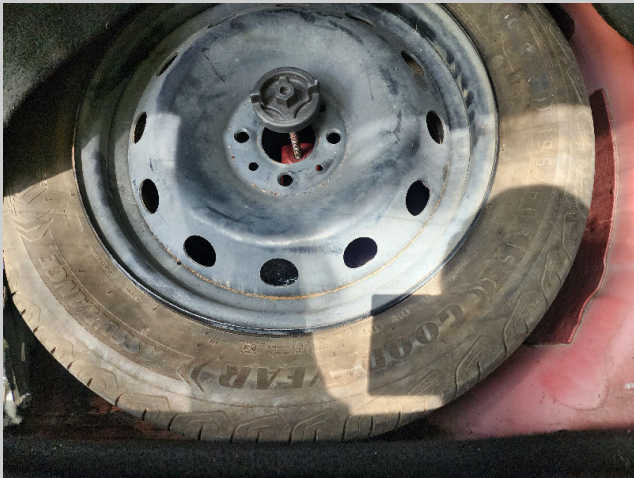
| Part | Status | Reason | Comment |
|---|---|---|---|
| Spare wheel | Not ok | | Need replacement |

Need replacement

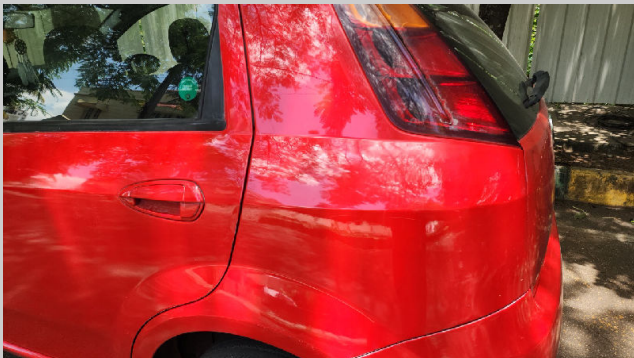
| Part | Status | Reason | Comment |
|---|---|---|---|
| LH Quarter Panel | Not ok | Repainted good quality | |

Repainted good quality

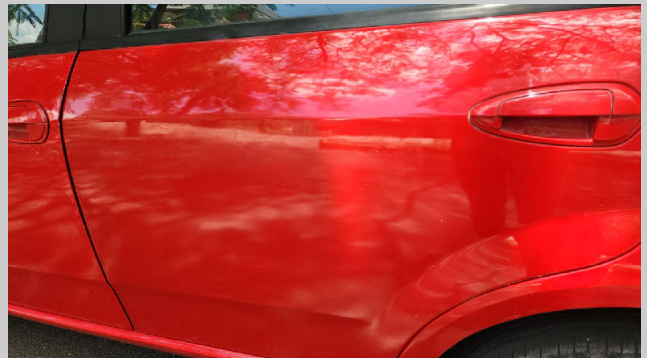
| Part | Status | Reason | Comment |
|---|---|---|---|
| LH Rear Door | Not ok | Repainted Bad Quality | |

Repainted Bad Quality

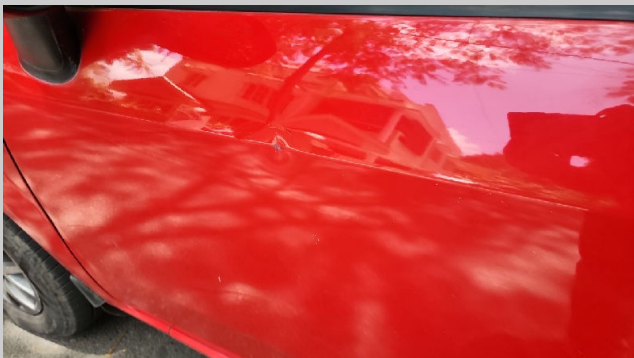
| Part | Status | Reason | Comment |
|---|---|---|---|
| LH Front Door | Not ok | Repainted good quality, Major or Multiple Dents | |

Repainted good quality, Major or Multiple Dents

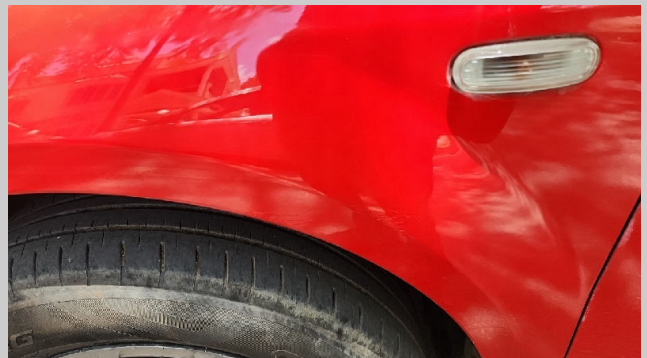
| Part | Status | Reason | Comment |
|---|---|---|---|
| LH Fender | Not ok | Major or Multiple Scratches | |

Major or Multiple Scratches

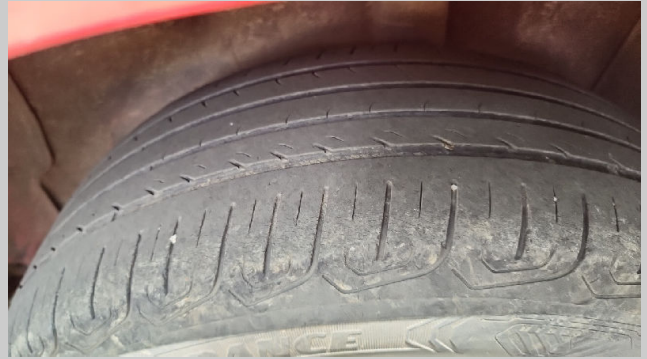
| Part | Status | Reason | Comment |
|---|---|---|---|
| LH Rear Tyre | Not ok | Tyre Need Replacment | |

Tyre Need Replacment

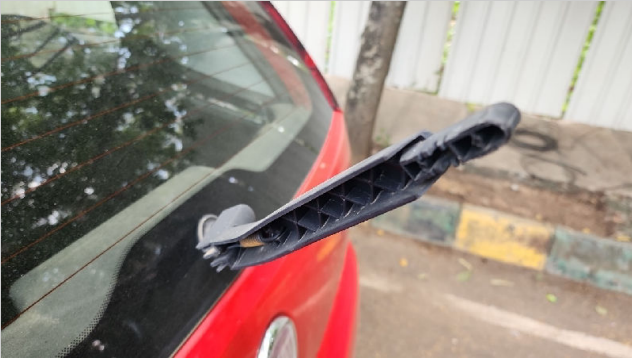
| Part | Status | Reason | Comment |
|---|---|---|---|
| Wiper Rear | Not ok | Noisy | no wiper blade |

Noisy

no wiper blade

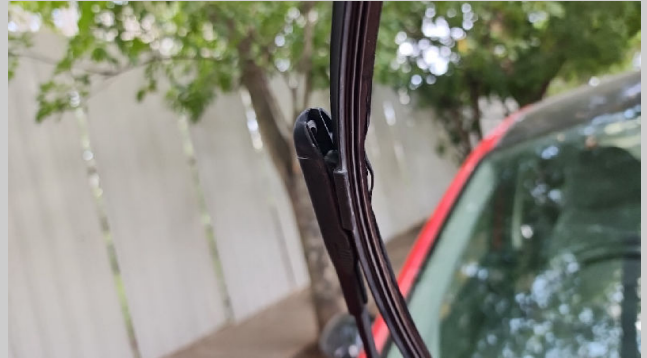
| Part | Status | Reason | Comment |
|---|---|---|---|
| Wiper Front | Not ok | Wiper blades need replacement | no wiper blade |

Wiper blads need replacement

no wiper blade

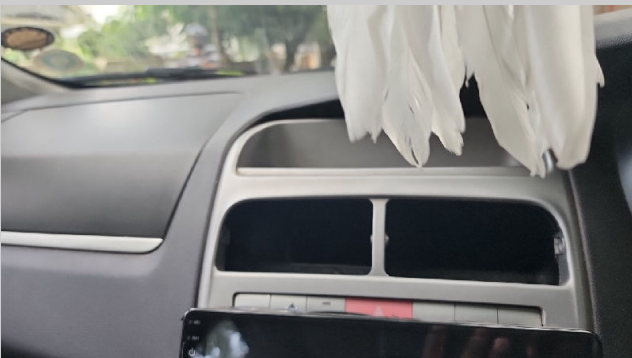
| Part | Status | Reason | Comment |
|---|---|---|---|
| AC Vents Condition? | Not ok | Broken or Missing Co Driver Side | |

Broken or Missing Co Driver Side

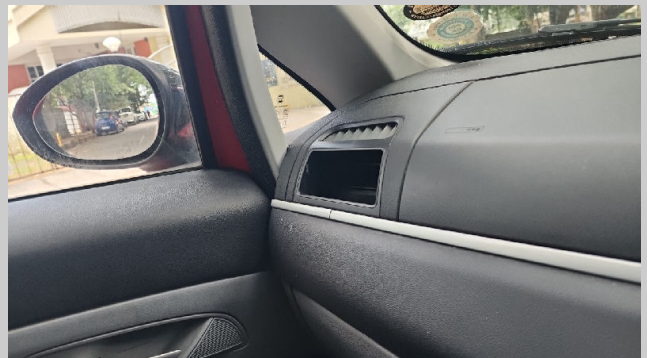
AC Vents Condition?

Broken or Missing Co Driver Side

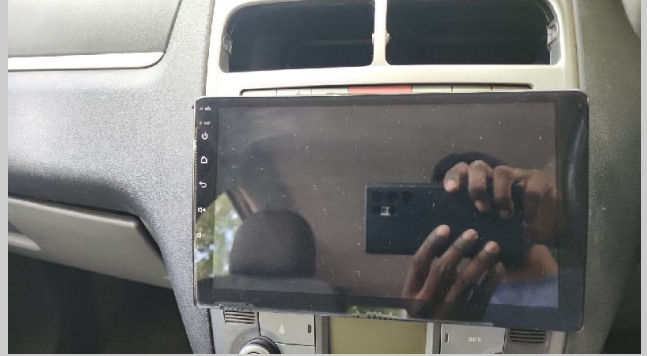
| Part | Status | Reason | Comment |
|---|---|---|---|
| Music system - Touch Screen | Yes | No Navigation | |

No Navigation
